## Troubleshooting Tips

### #15 – Sealing MTI (D&H) Pulsers to Prevent Water Damage

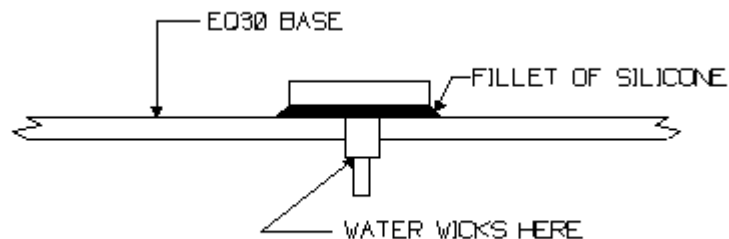
Water is the biggest cause of Pulsar Failure on D&H EQ30 Heads. Almost 90 percent of the units being returned under warranty have signs of moisture having been present on their shaft.

We think the problem comes from condensation forming on the metal plate on which the Pulsar is mounted, then running down under the Pulsar and down it's shaft where it "wicks" up the shaft and into the Pulsar.

We suggest sealing the Pulsar after it is mounted by running a bead of silicon around it to prevent water getting underneath it (see Figure 1 below). We are ensuring that any Pulsers shipped from National Parts Distributing Ltd. have been sealed at any joints in the Pulsar and where the wires enter the Pulsar. If you have a Pulsar which is not sealed you should also seal all joints on the body and where the wires enter with silicone.
